Technical Bulletin TB - 0109

To : All Trailer Mounted 120 Machine Owners
From: Malcolm North
Date: 26/06/2014
Our Ref TB- 0109
Re: Cracked Cylinder

Affected: All Trailer Mounted 120's Produced since 1985 to Present

Mandatory Safety Check – 120M/H/T

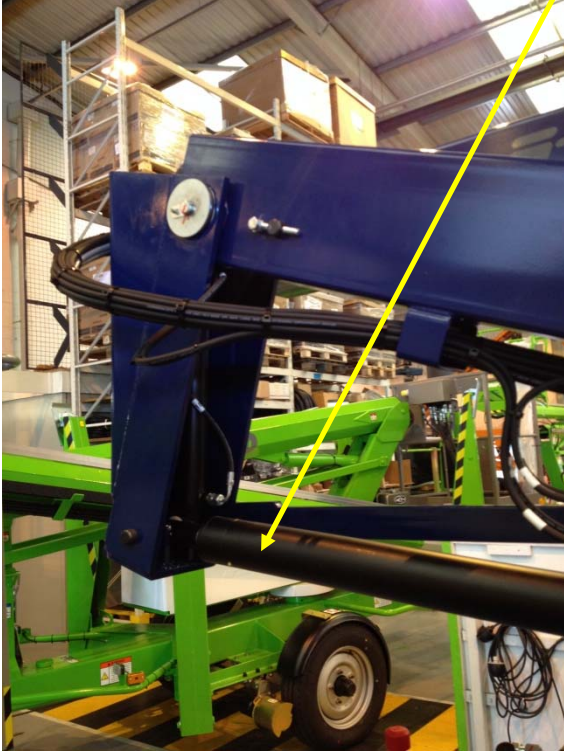
Fig 1.

It has been identified that over time lift cylinder 2 (fig.1) may suffer from material fatigue around the shaft pivot point (fig.3). Our findings point to a number of potential factors that may contribute to this fatigue such as vibration through road transport, lack of boom travel clamp and impact to the machine structure.

Cylinder Location:

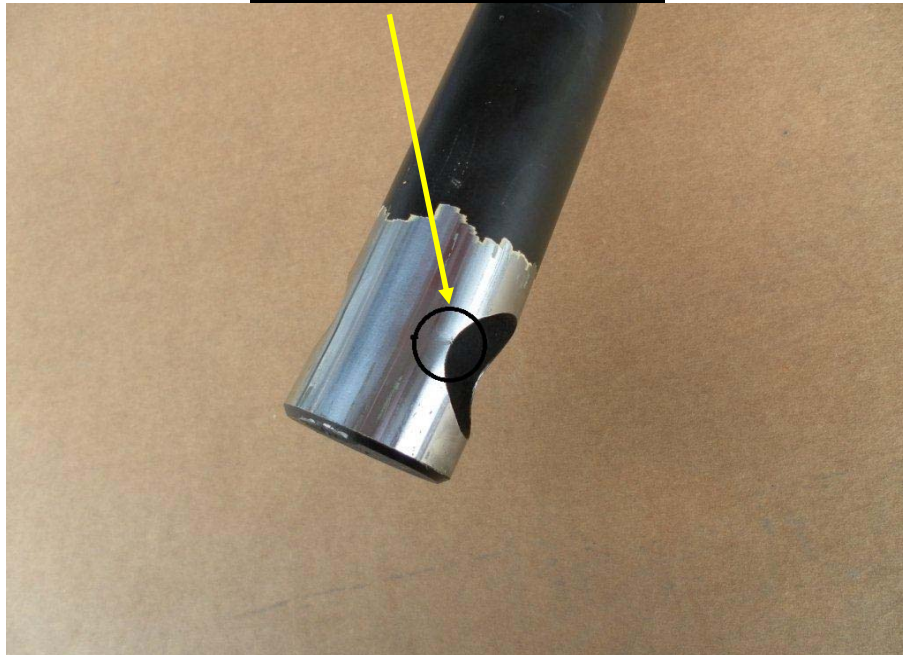
Fig 3. Example of cracking:

In light of this, it is recommended that in addition to the daily/weekly/monthly inspections an additional visual inspection of the cylinder must take place immediately. The cylinder can be visually inspected at rest on the upper surface, then again for the bottom surface by operating the cylinder in question to full height. During the inspection, if the paint surface has not cracked then no further action is required. Should the paint show signs of cracking then removal of the paint would be required for a closer inspection of the chrome shaft.

Any cylinder found to show signs of cracking must be replaced immediately and the machine load tested.
