**Drive Block CT7 Piston Replacement**

**Instruction No.:** HR28\_CI01

**Product:** HR28

**Operation:** Replace the CT7 piston valve within drive block P28571

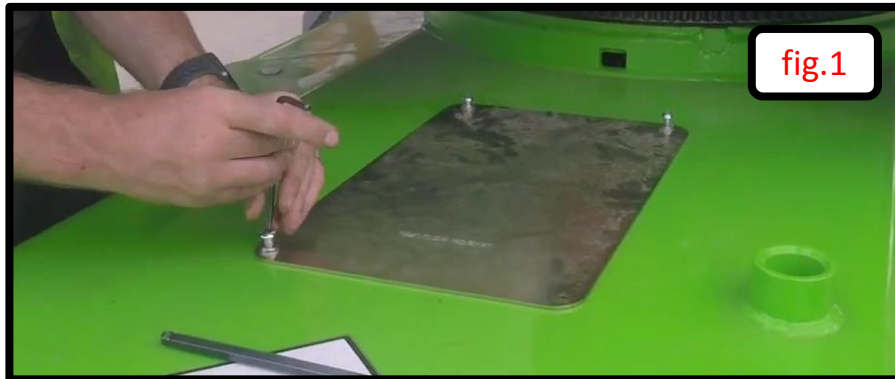
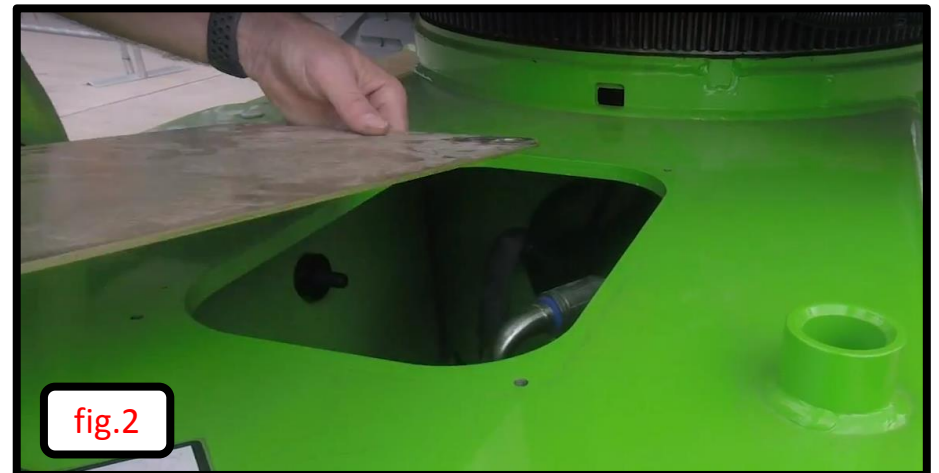
## 1. Remove the rear top chassis cover.

Using the 5mm allen key unscrew the 4x M8 button cap bolts (fig.1) and remove the top rear chassis cover to gain access to the main drive block (P28571) (fig.2).

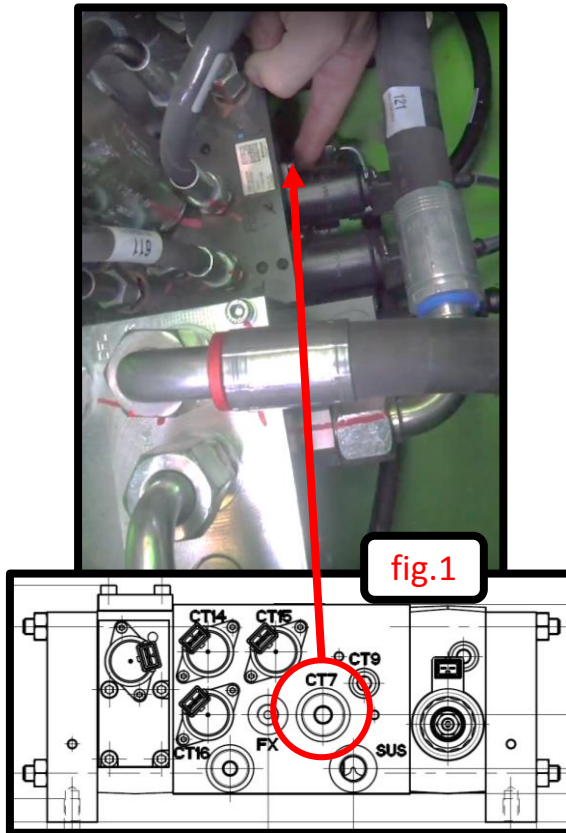
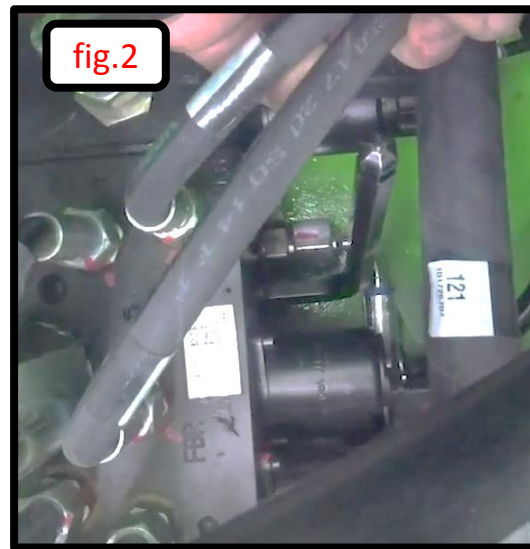
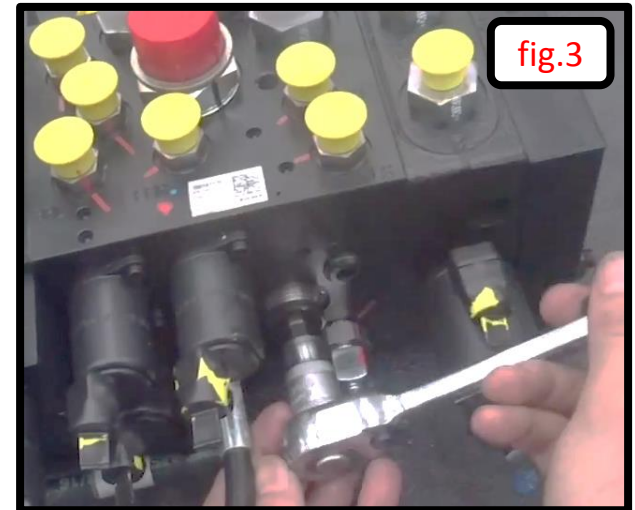
## 2. Remove the CT7 port plug.

Locate port CT7 on the right hand side of the drive block (fig.1). Using a 10mm Allen key and nylon hammer break the initial tension in the plug (fig.2), then using a ½" ratchet and ½" 10mm hex socket remove the plug (fig.3), exposing the 3-piece piston valve. For the purposes of this instruction all future photos are of a block external from the chassis. Please be advised, hydraulic oil will be present when removing the plug.

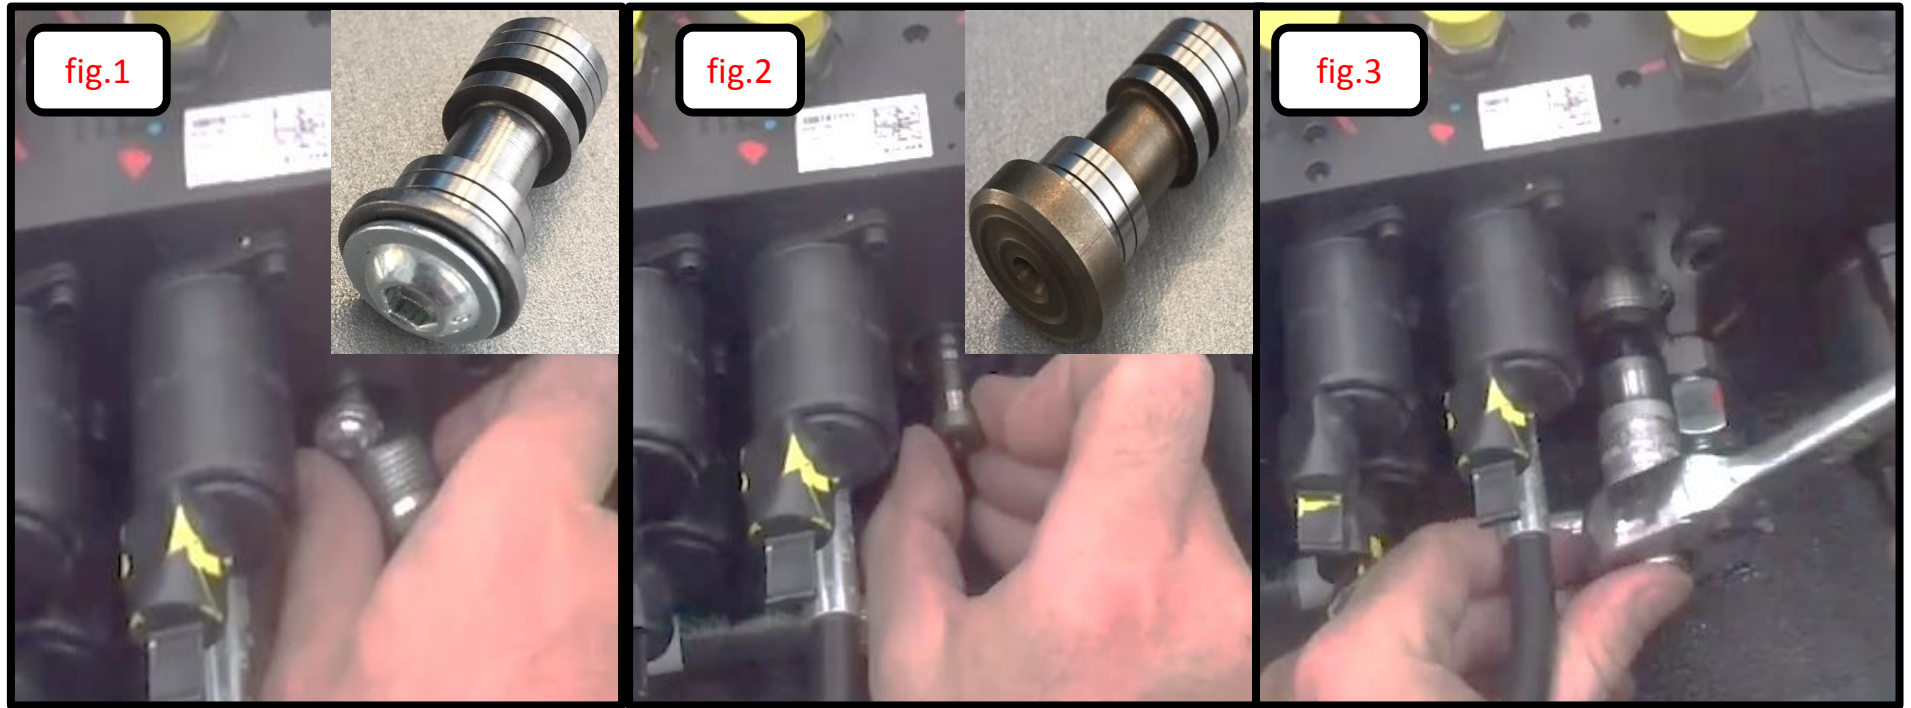
3. Replace the 3-piece piston valve.

Remove the 3-piece piston valve from port CT7 (fig.1) ensuring the spring behind it remains in place and replace it with the single piece piston valve (P32504) (fig.2). Lock the piston back in place with the CT7 plug (fig.3).

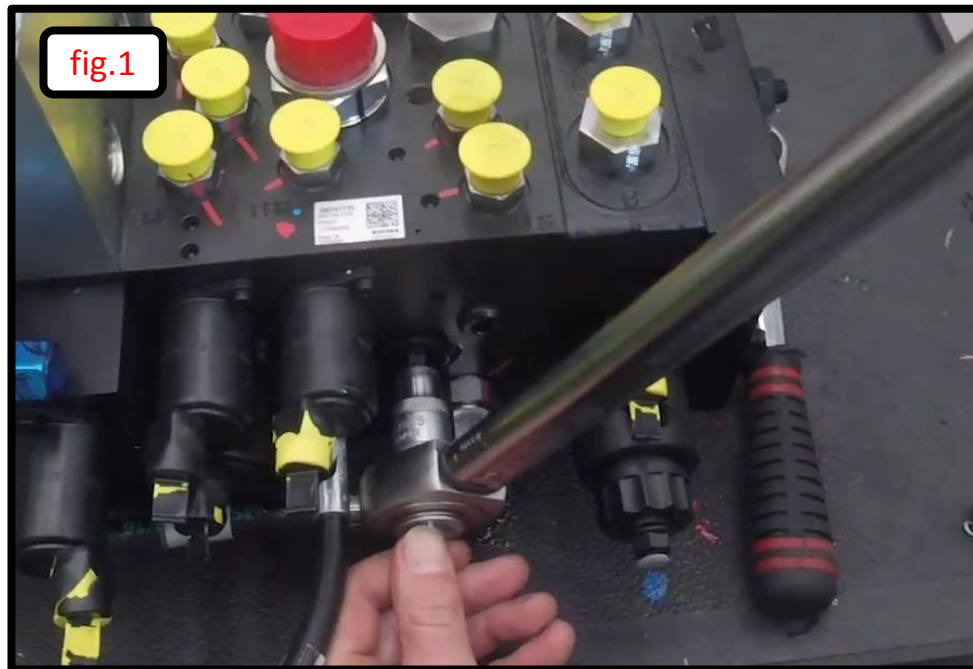
## 4. Torque the CT7 plug.

Using a ½" SQ DR torque wrench & ½" 10mm hex socket, torque the CT7 plug to 65Nm (fig.1).
