**Drive Block CT7 Piston Replacement**

**Instruction No.:** SP85\_CI01

**Product:** SP85

**Operation:** Replace the CT7 piston valve within drive block P28571

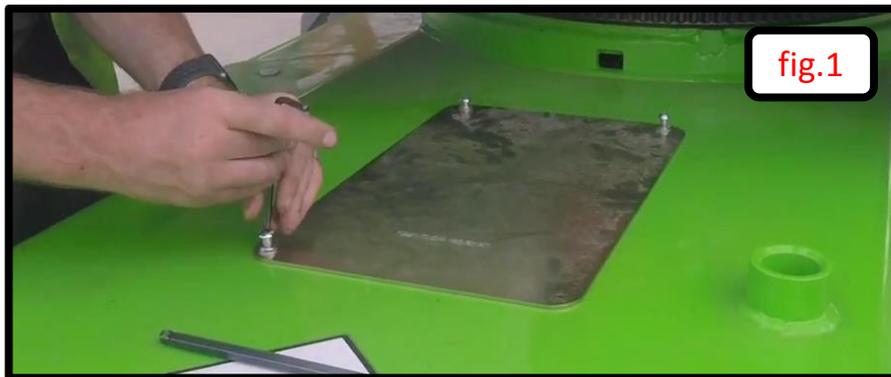
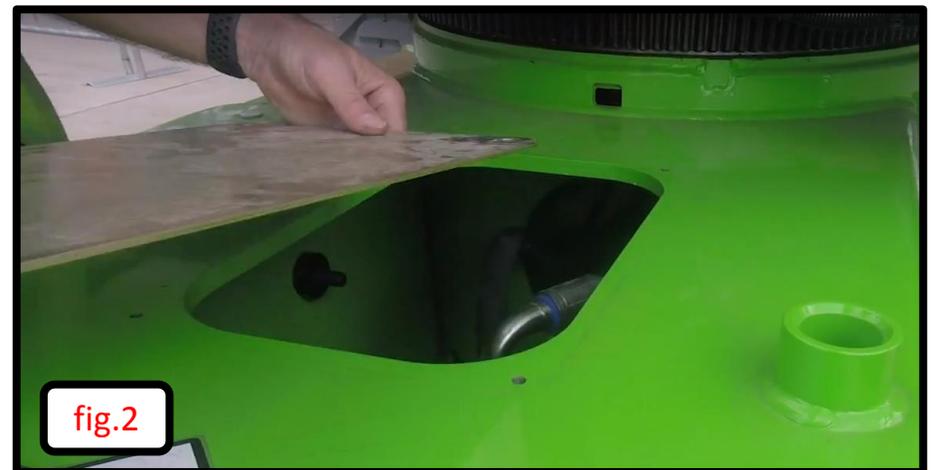
## 1. Remove the rear top chassis cover.

Using the 5mm allen key unscrew the 4x M8 button cap bolts (fig.1) and remove the top rear chassis cover to gain access to the main drive block (P28571) (fig.2).

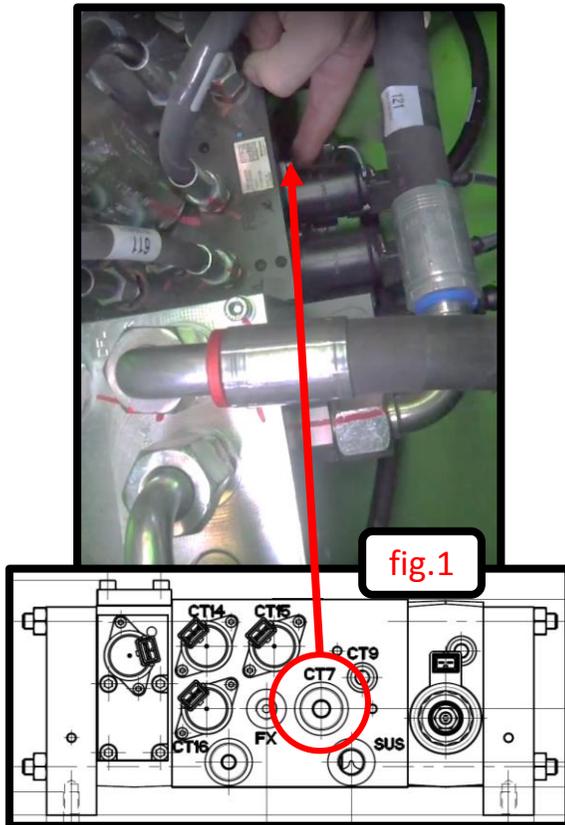
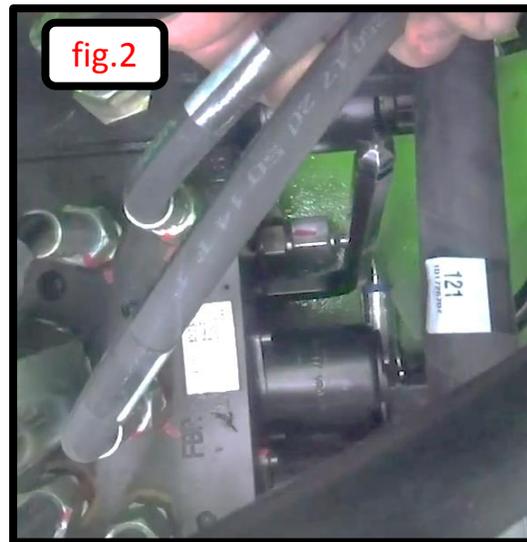
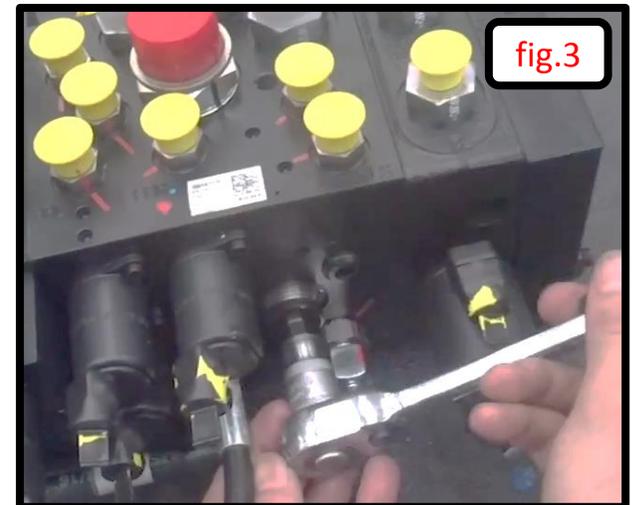
## 2. Remove the CT7 port plug.

Locate port CT7 on the right hand side of the drive block (fig.1). Using a 10mm Allen key and nylon hammer break the initial tension in the plug (fig.2), then using a ½" ratchet and ½" 10mm hex socket remove the plug (fig.3), exposing the 3-piece piston valve. For the purposes of this instruction all future photos are of a block external from the chassis. Please be advised, hydraulic oil will be present when removing the plug.

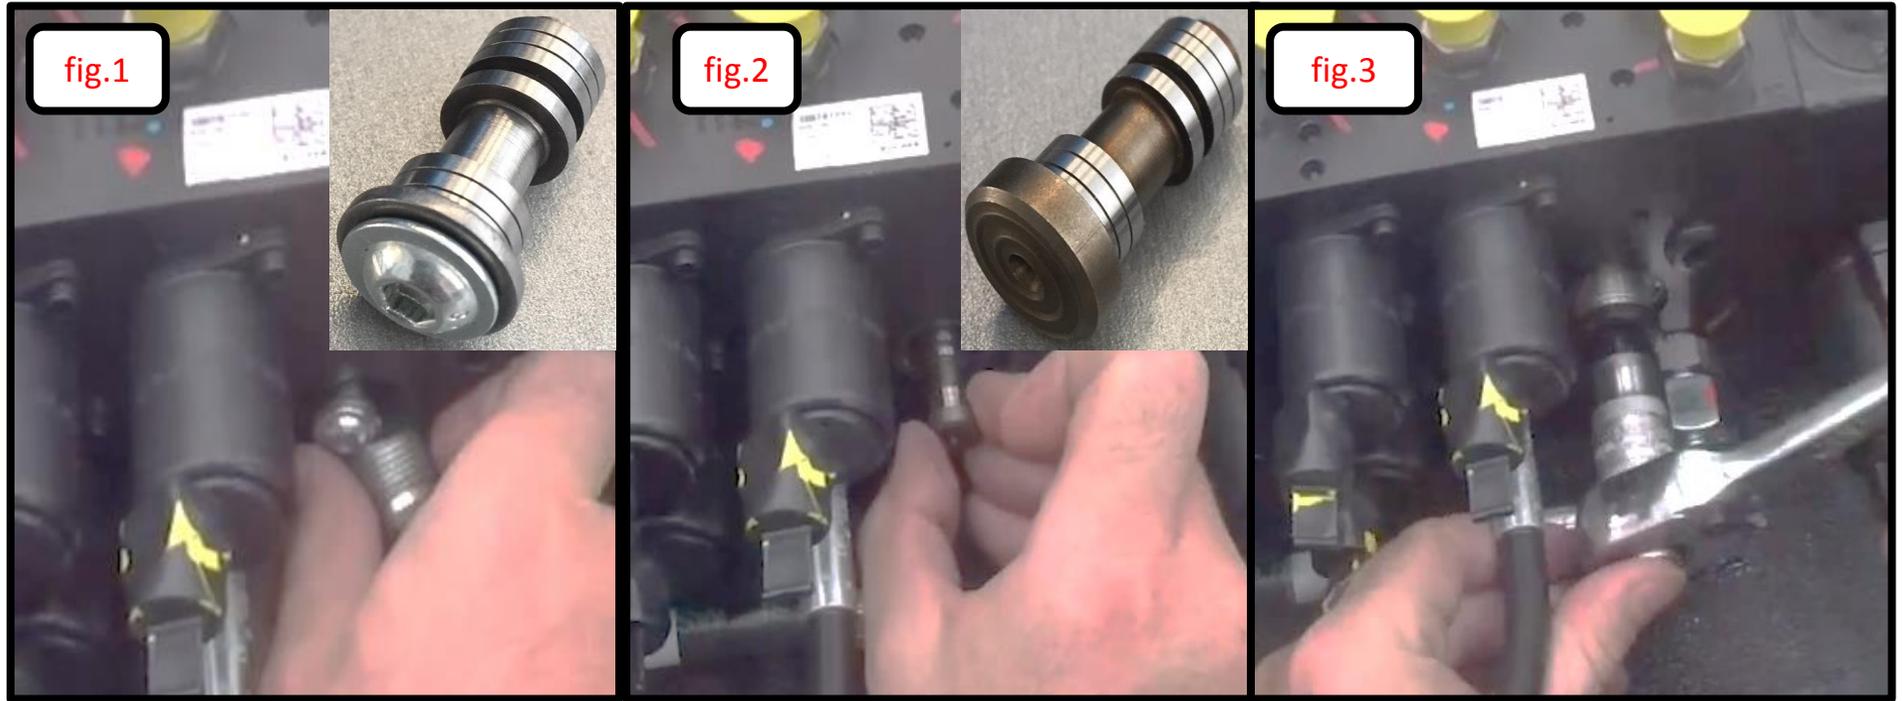
3. Replace the 3-piece piston valve.

Remove the 3-piece piston valve from port CT7 (fig.1) ensuring the spring behind it remains in place and replace it with the single piece piston valve (P32504) (fig.2). Lock the piston back in place with the CT7 plug (fig.3).

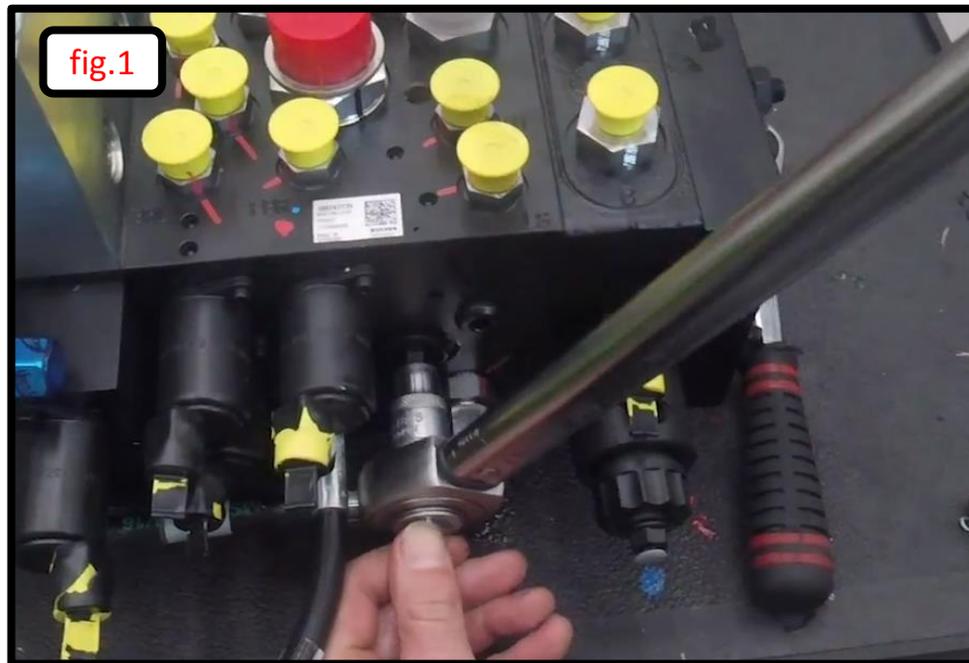
## 4. Torque the CT7 plug.

Using a ½" SQ DR torque wrench & ½" 10mm hex socket, torque the CT7 plug to 65Nm (fig.1).
