Technical Bulletin: - TB0118

Re: Mandatory Inspection

Machines affected: HR28 (All power variants and countries)

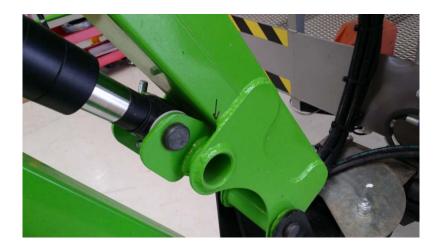
It has been identified that the P26732 Upper Flyboom fabrication used on the Niftylift HR28 may suffer from fatigue near the ram pickup location.

All HR28 machines <u>must</u> be inspected immediately to determine if the component has started to crack. The location on the machine is shown in Figure 1 and an example crack is shown in Figure 2 on Page 2.

If a crack is observed in the flyboom paintwork then the machine must be immediately withdrawn from service.

If no evidence of cracking is shown then the machine may continue to be used. The inspection of this location must be repeated weekly in addition to normal daily/weekly/monthly inspections as defined in the machine's Operating Manual.

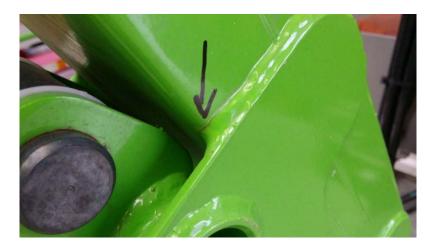
Figure 2

Our findings suggest that this component may crack, and if not addressed could potentially lead to structural failure. External non-service loads induced by cage impact or failure to support the cage during transportation may accelerate component degradation.

If at any subsequent time a crack is identified, then the machine must be removed from service.

Niftylift Service Department will advise a delivery time for a replacement part. Every endeavour will be made to do this in the very near future.
